A LIMITED ENERGY STUDY OF
HIGH TEMPERATURE AND CHILLED WATER DISTRIBUTION SYSTEMS
AT FORT STEWART AND HUNTER ARMY AIRFIELD, GEORGIA

VOLUME ES
EXECUTIVE SUMMARY

FINAL SUBMITTAL

Prepared by
Reynolds, Smith and Hills, Inc.
4651 Salisbury Road
Jacksonville, Florida 32256
(904) 296-2000

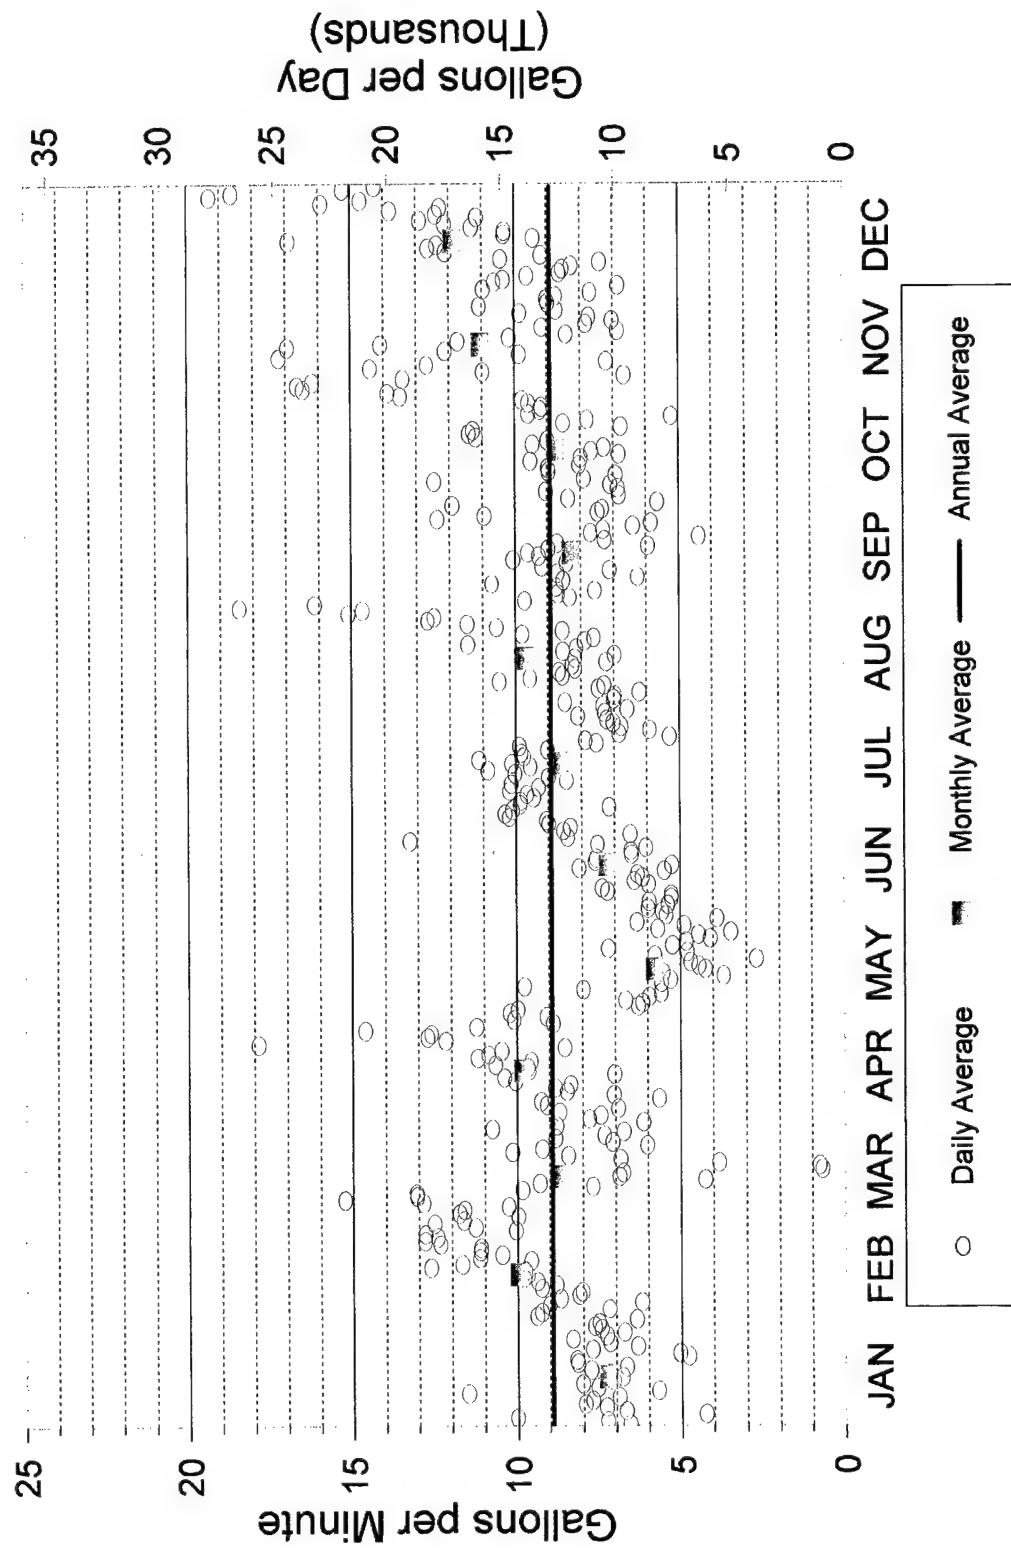
Figure 4.1-2
HTW Make-up Water Statistics, 1993

Figure 4.1-1 shows that the 1993 monthly make-up water was fairly constant for ten of the 12 months, averaging between five GPM (7,200 GPD) and ten GPM (14,400 GPD). The frequency (number of days) that various make-up water flow rates occurred and the HTW make-up water statistical data for 1993 are shown in Figure 4.1-2. The make-up water use for 1993 averaged approximately 8.9 GPM (12,800 GPD). There were a total of 15 days in 1993 that had a make-up water use of over 15 GPM (21,600 GPD).

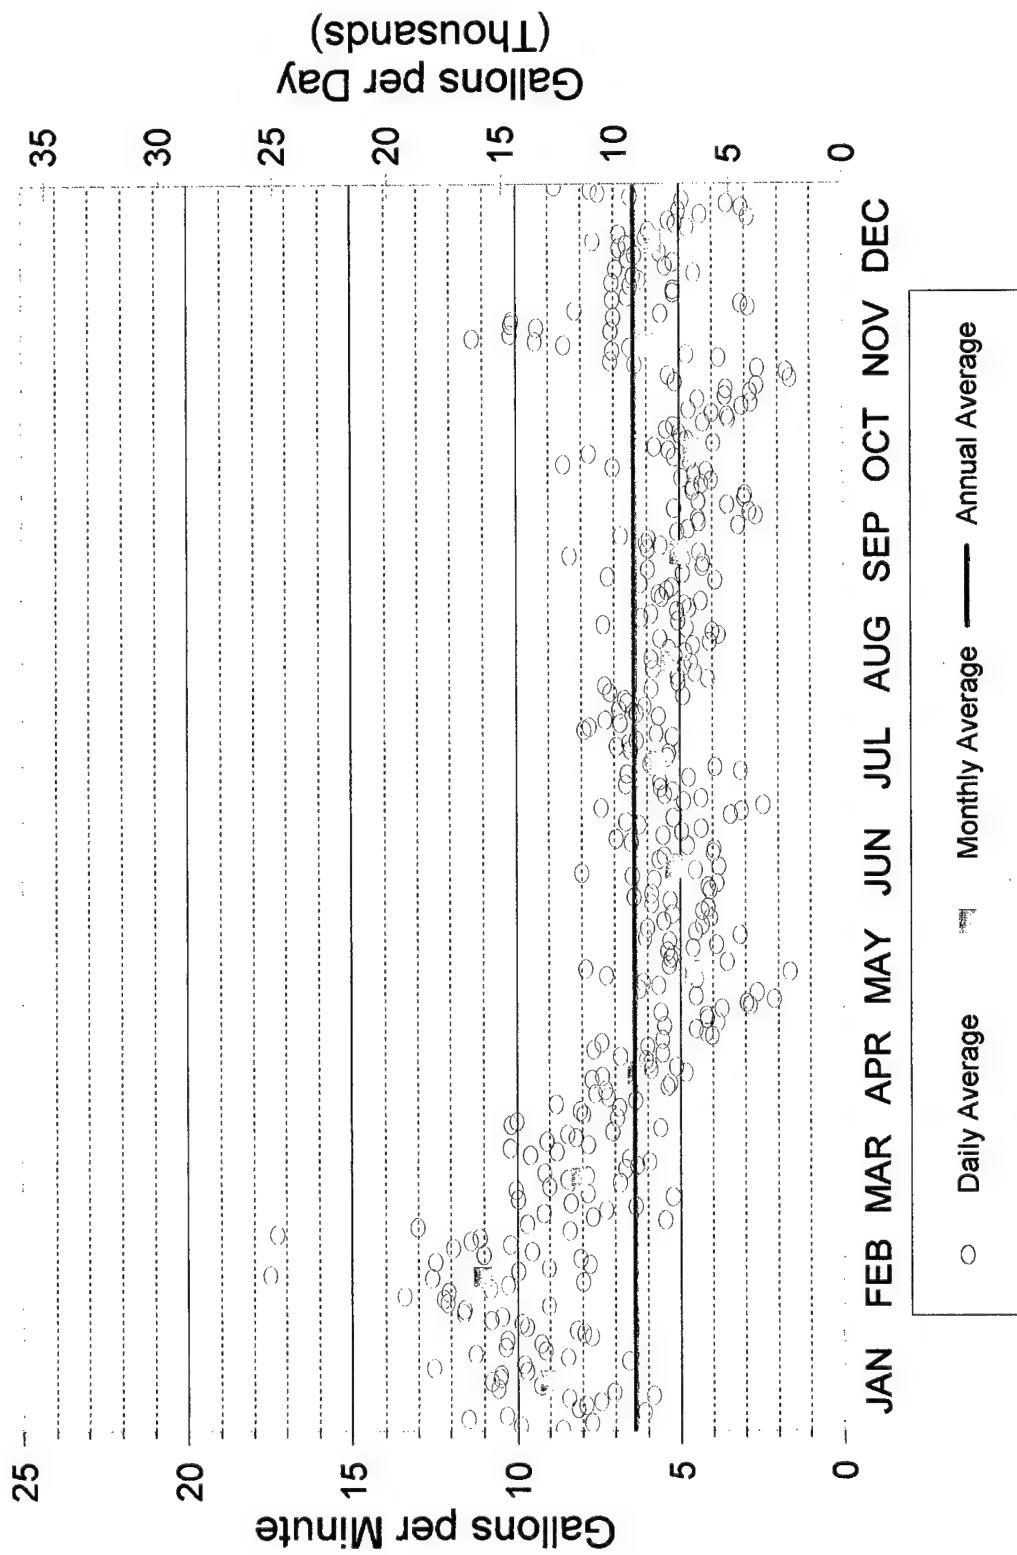
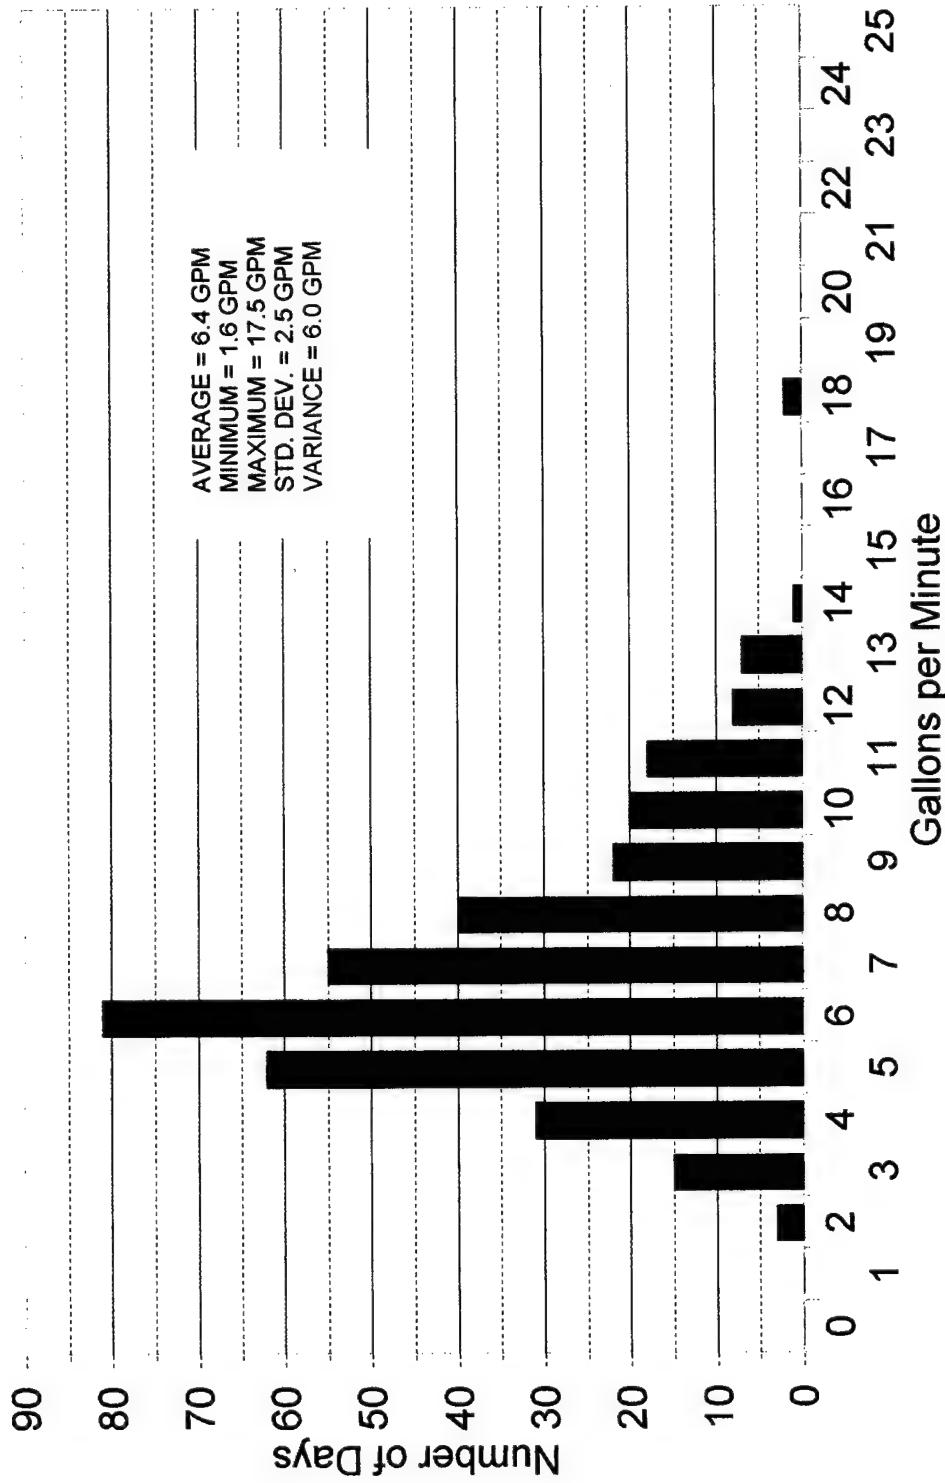
Figure 4.1-6
HTW Make-up Water Statistics, 1995

The frequency (number of days) that the various make-up water flow rates occurred and the HTW make-up water statistical data for 1995 are shown in Figure 4.1-6. The make-up water use for 1995 averaged approximately 6.4 GPM (9,200 GPD). There were two days in 1995 that had a make-up water use of over 15 GPM (21,600 GPD) and they were both due to known leaks in the HTW system.

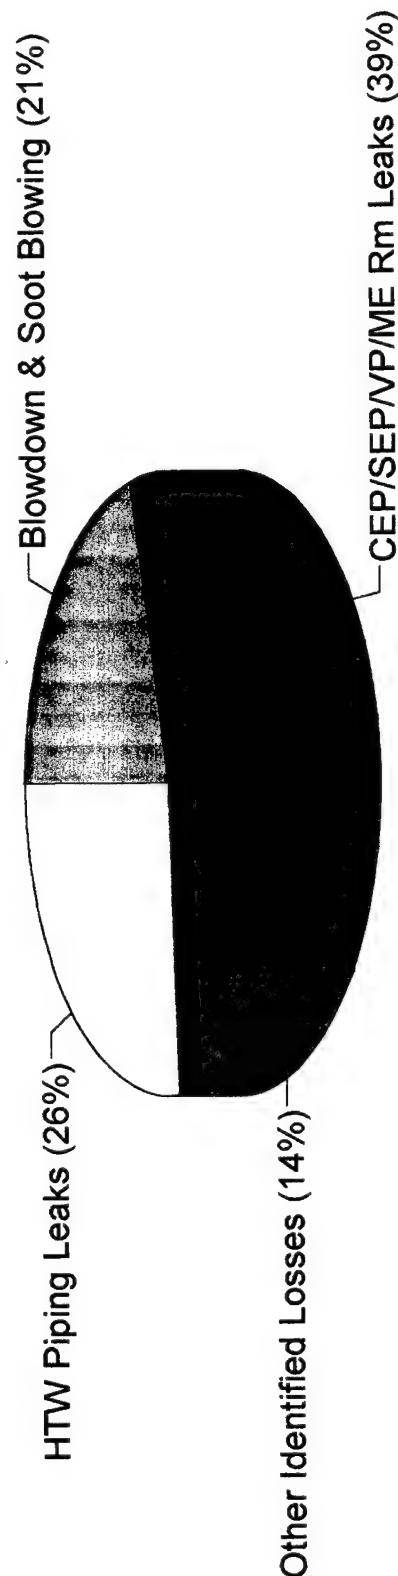
Figure 4.2-1
Fort Stewart HTW Loss Estimates, 1995

The estimated losses for the HTW piping distribution system are between 1.44 GPM (2,070 GPD) and 1.66 GPM (3,650 GPD). Figure 4.2-1 shows the percentage of total HTW losses that can be attributed to blowdown and soot blowing, miscellaneous valve and fitting leaks, other identified losses and to leaks in the HTW

underground piping system. The HTW piping leaks represent about 26 percent of the total HTW losses; however, with a total of only about 1.5 GPM of leaks spread fairly evenly over 28 sections of HTW supply and return pipes, the cost of finding and repairing these leaks would be high. The remaining 74 percent of the losses are above ground, accessible and much more cost effective to repair.
